Certified Record of Proceedings

Structural Condition Inspection and Site Analysis of:

757, 765, 771, 777, 783, 791, & 793 Busti Avenue, Buffalo New York

March 26, 2009

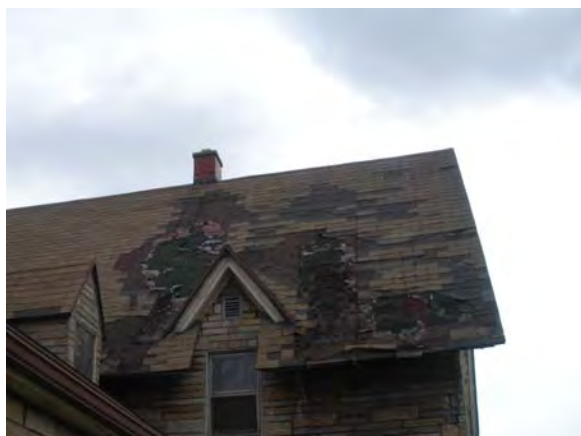
This building consists of two separate roof lines. The 2-story portion of the building consists of a gable roof oriented east-to-west. The single story portion of the building consists of a gable roof oriented north-to-south. On the west side of the single story wing are two gabled windows and a flattened section of the roof. The roofing on the two gabled roofs consists of three tab asphalt shingles. The shingles are in poor condition with several noticeable areas of cracked, deteriorated, or missing shingles on the north and south sides of the main building as shown in photographs 757-2 and 757-5. There is evidence of water leaking into the building on the west side of the north wing where it adjoins to the main building as shown in photograph 757-6. The flat section of the roof located west of the north wing is missing all the roofing material and the roof deck is rotted. Photograph 757-7 and 757-8 below shows the flat roof, the missing roofing material and the rotted roof deck.

Photograph 757-5: North face of main roof

the entire structure should be replaced to prevent water from leaking into the interior space and further deteriorating the structure. The decking to the flatted roof of the section west of the north wing should be replaced to prevent roof collapse. To keep the foundation stable, all basement openings, especially the exterior basement entrance door, should be resealed to minimize any further water infiltration into the basement. All broken windows should be boarded up to further prevent moisture infiltration in the interior building space.

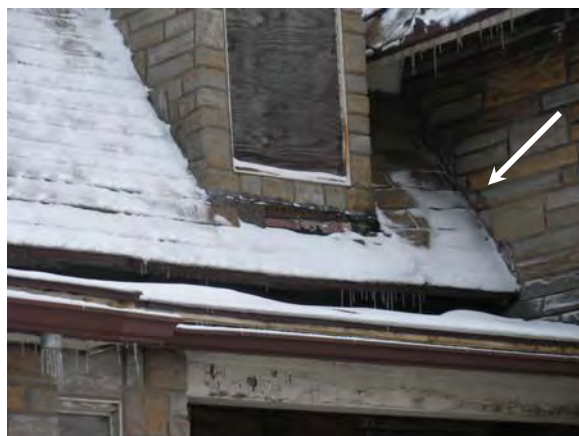
Photograph 757-6: North West side of roof at leak

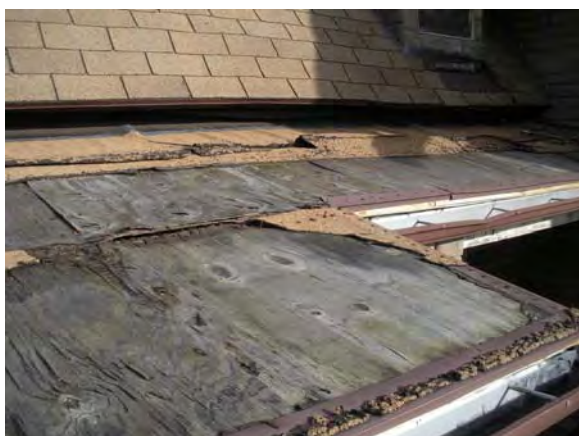
Photograph 757-7: Flatted section of roof to the west of the north wing gable roof

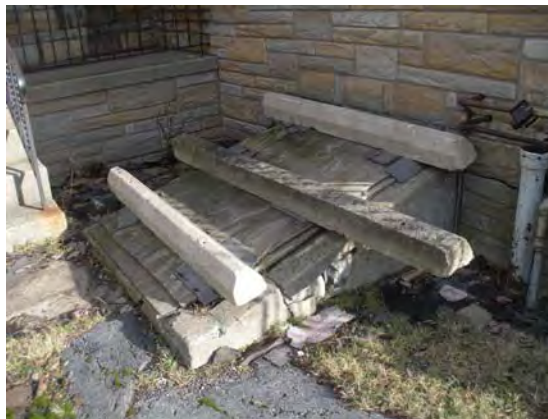
The bulkhead door, which provides exterior access to the basement, is deteriorated as shown in photograph 757-9. There are visible signs that water is leaking through this opening into the basement below.

Photograph 757-9: Exterior basement entrance

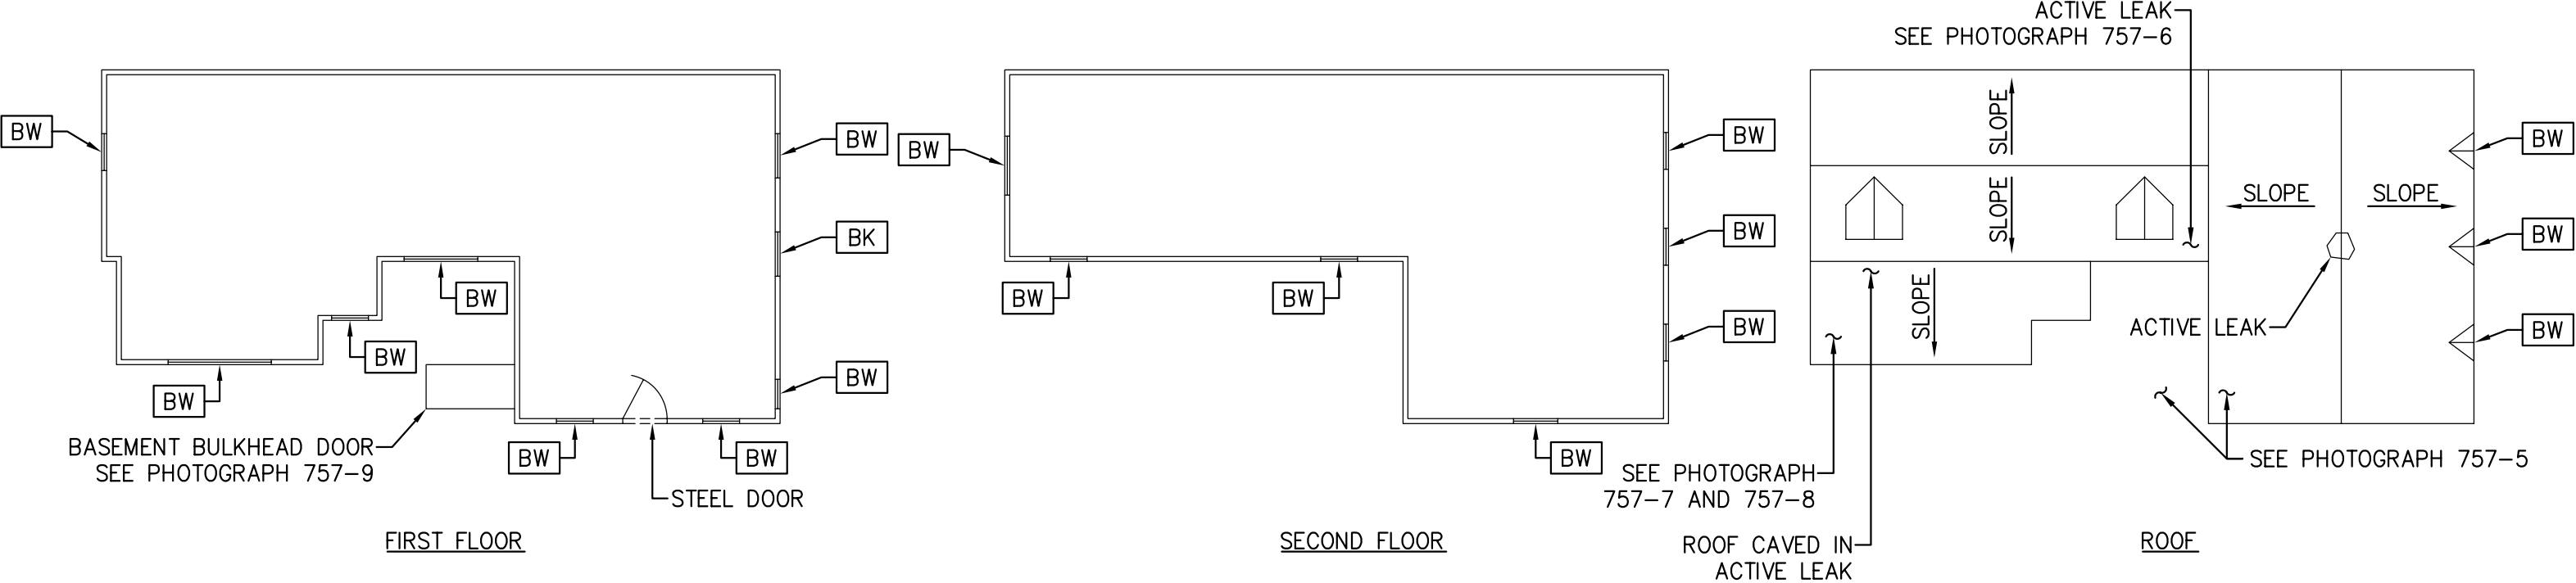
The exterior doors and windows were visually inspected for weather tightness. The condition of all the windows is shown in Drawing S-757.

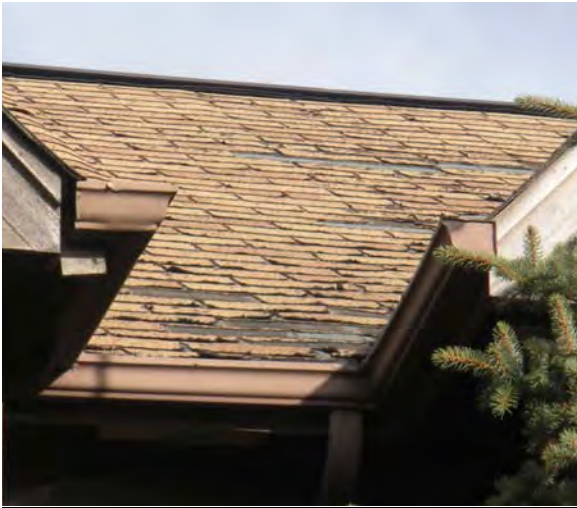
The main 2-story building consists of a gable roof oriented north-to-south, with a similar roof line and pitch over the single story garages. Multiple gables extend from the main roof to the west to reveal windows and architectural overhangs. The roofing material on all roof faces consists of three tab asphalt shingles. The shingles on the main roof of the building are in poor condition and are starting to deteriorate. The shingles over both garages are also in poor condition with several areas of cracked and deteriorated lapped tabs. The condition of the roofing on both roof levels are shown in photographs 765-5 through 765-10 below.

Photograph 765-5: West Face of Upper Roof

The overall structural assessment of this building is that it is in stable condition. The roof shingles should be replaced to prevent any water from leaking into the interior space that would deteriorate the structure below. The water in the basement should be removed to prevent mold and damage to the first story floor framing system. All broken windows should be boarded up to prevent further moisture infiltration into the interior building space.

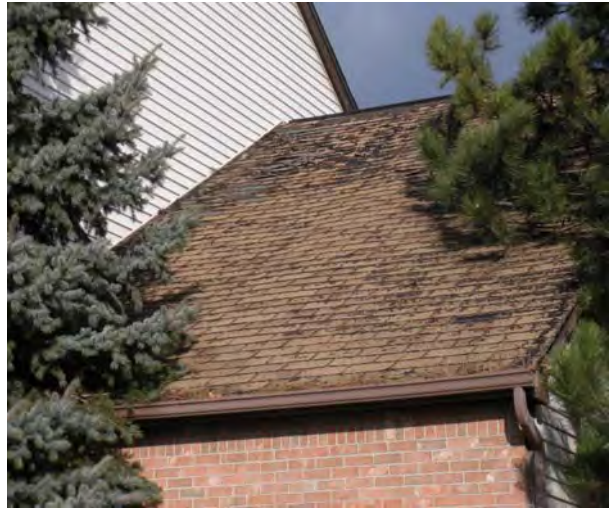
Photograph 765-6: West elevation of duplex #2

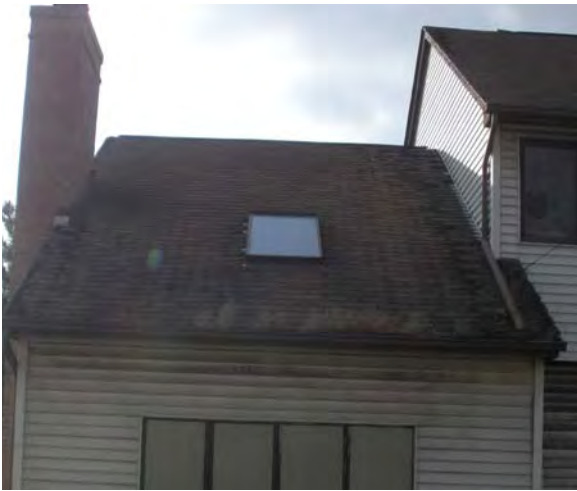
Photograph 765-7: East face of lower roof of duplex #2

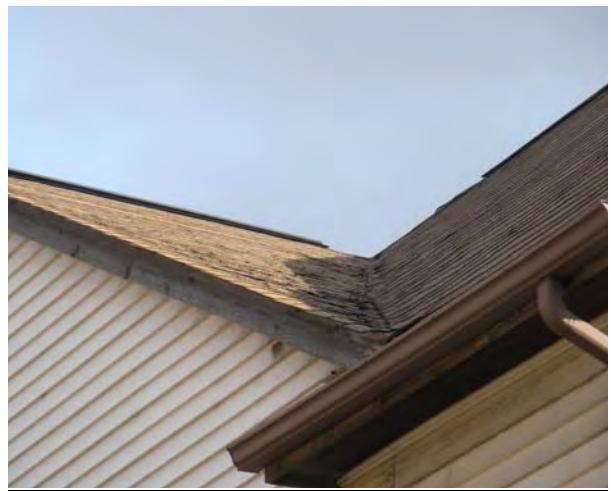
Photograph 765-8: West face of upper roof at valley

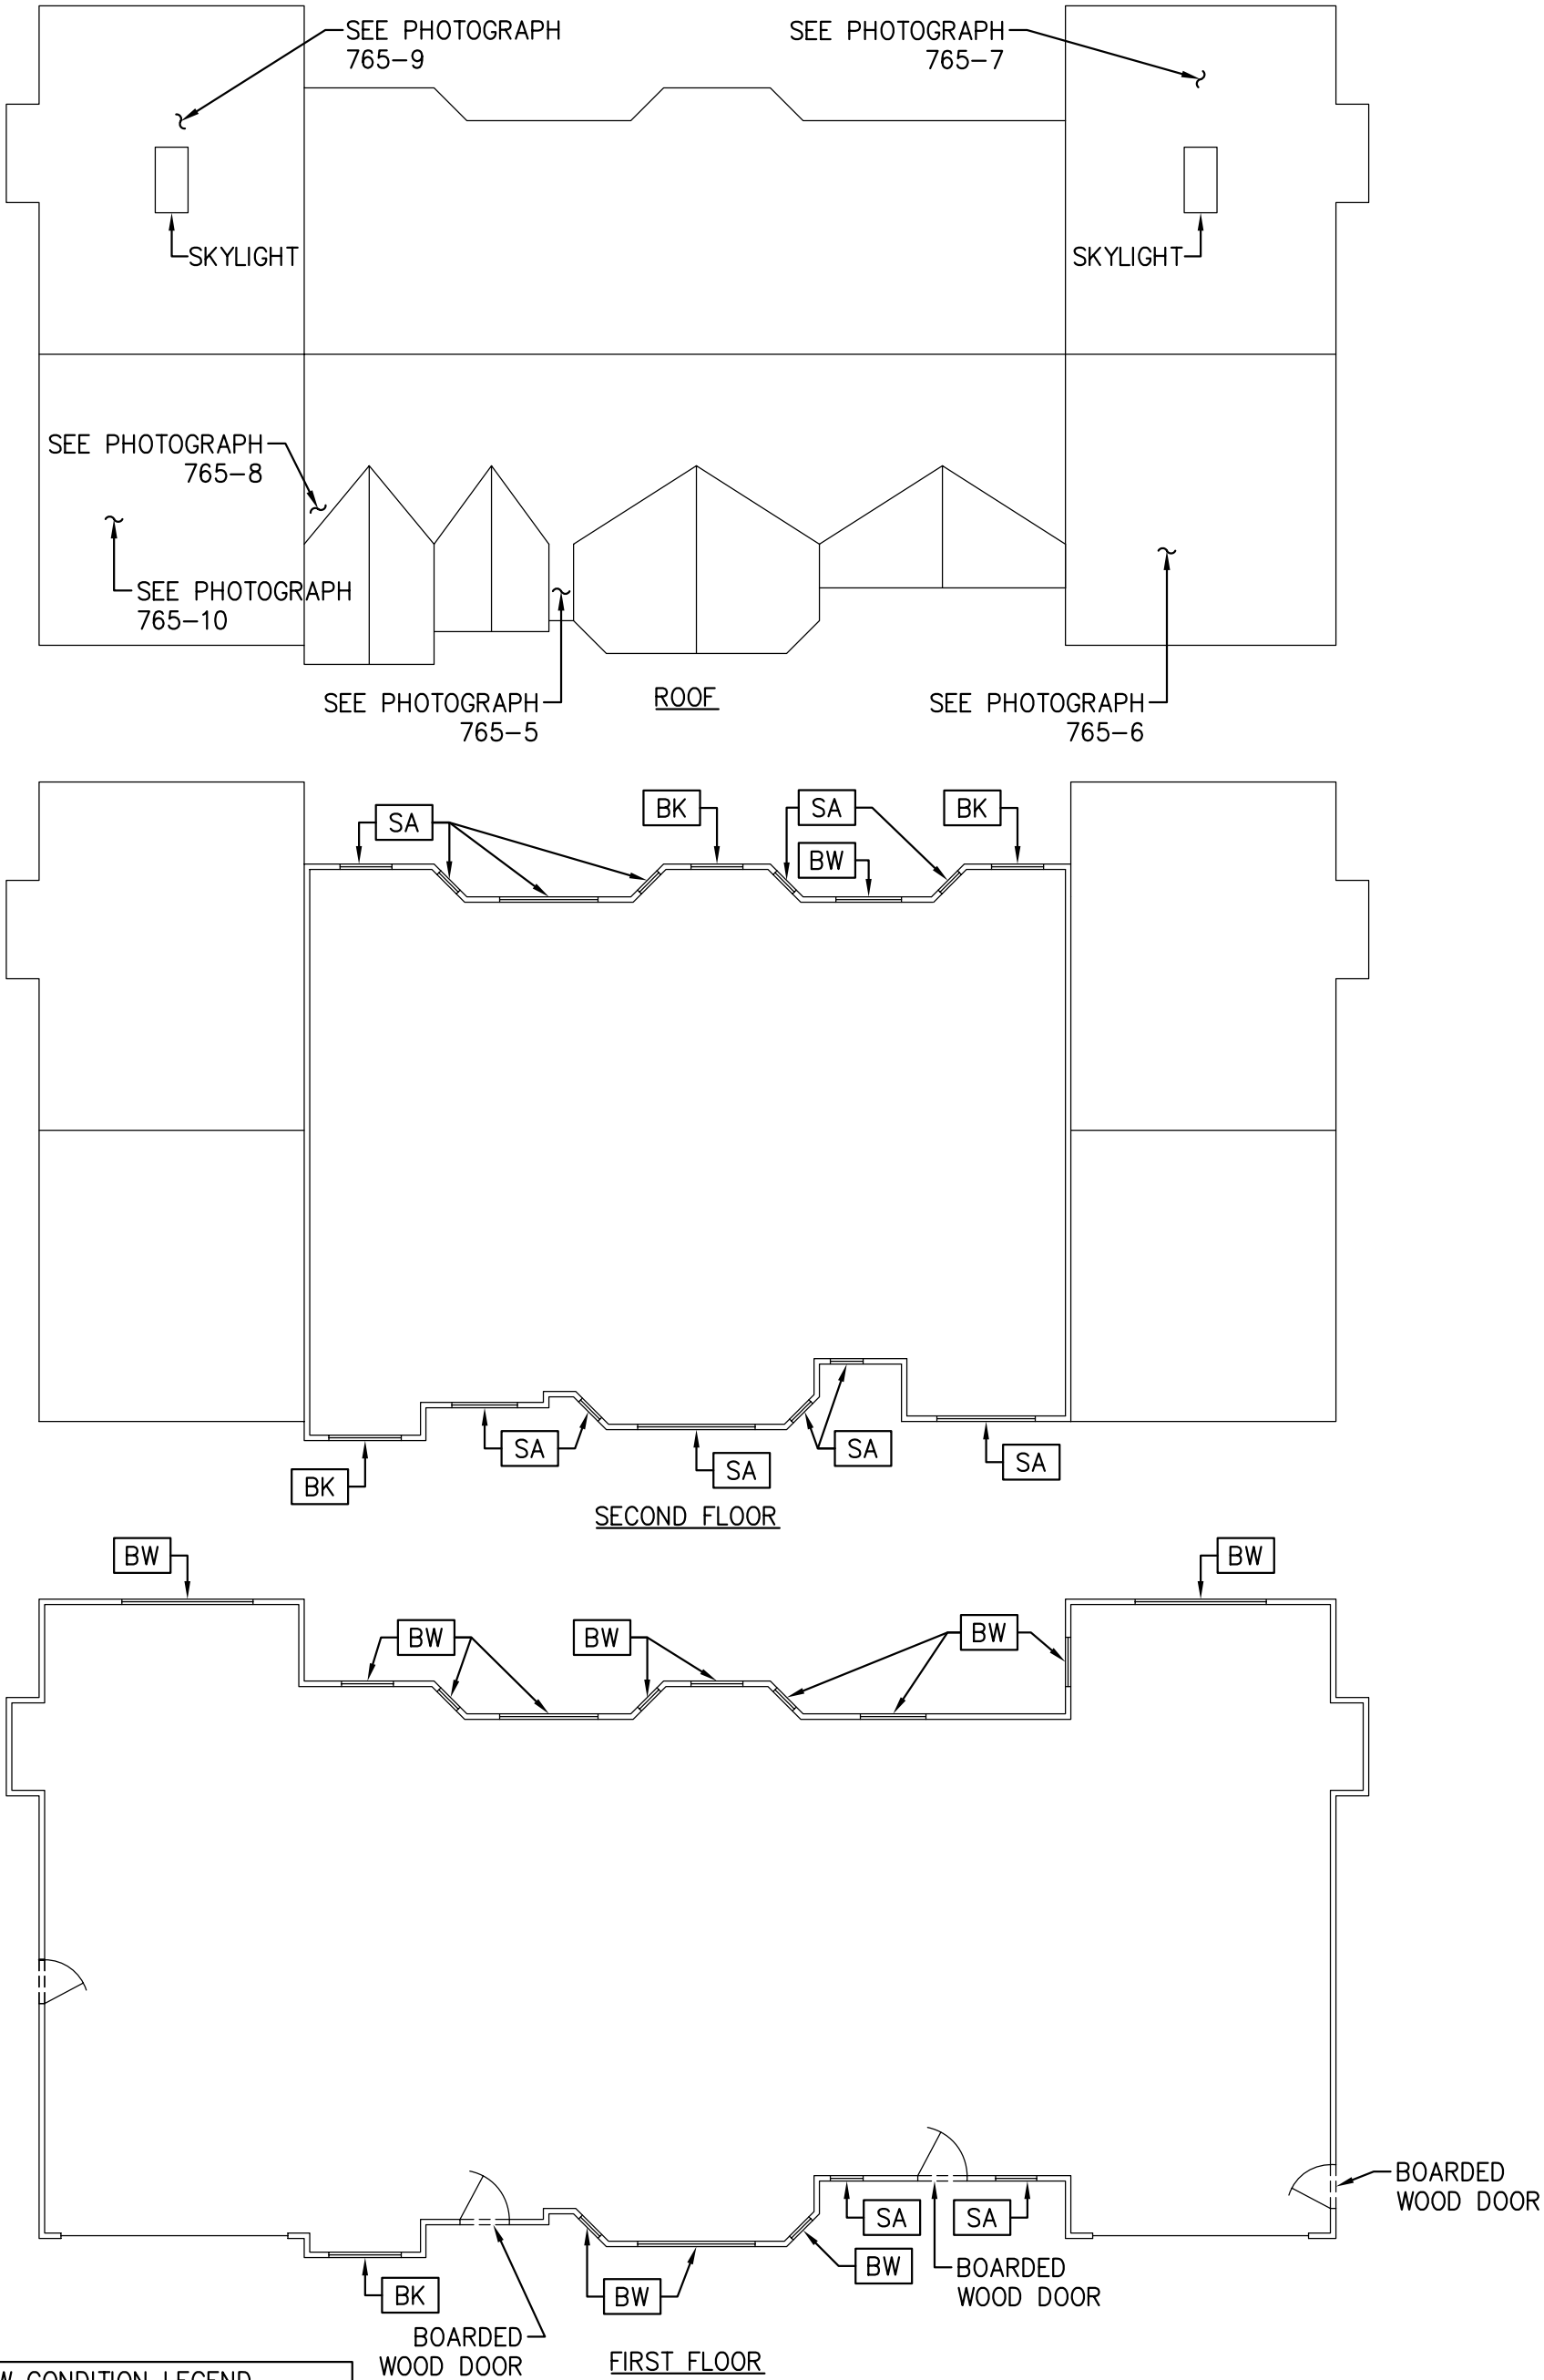
The exterior doors and windows were visually inspected for weather tightness. The condition of all the windows is shown in Drawing S-765.

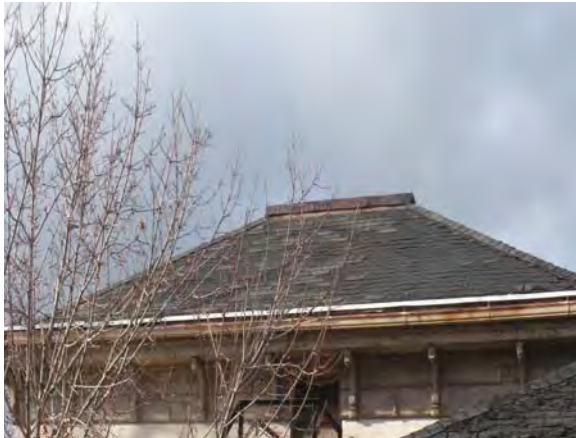
The roof of the main structure is a modified hip with a flattened section at the very top. The south wing is a half hip and the east wing is a gable roof oriented east-to-west. There are flat roofs over the back pantry and rear stairway and consequently both flat roofs have collapsed into the structure and are inaccessible for inspection. The remaining roofs could not be safely accessed for inspection based on the condition of the roof deck. The south wing, shown in photograph 771-6 below, has signs of sagging roof framing likely due to moisture infiltrating through the deteriorated roofing. Previous inspections of this property indicate the sloped portions of the roofs consist of three tab asphalt shingles which transition to 90 lb mineral coated roll roofing over the cornice area and flat areas. All the roofs that were stable are now in very poor condition as shown in photographs 771-5 through 771-8 below.

Photograph 771-5: South face of main modified hip roof

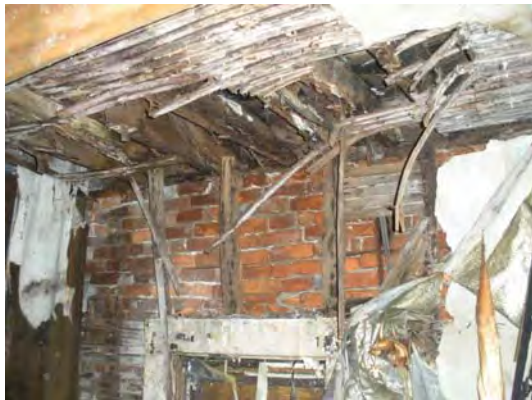
Photograph 771-9

The interior walls consist of rough sawn 2x4 stud construction with a lath and plaster wall and ceiling finish. The finish floors are a combination of carpet, linoleum and finish hardwood. There continues to be deficiencies in the plaster from water infiltration and damaging the plaster covering throughout the interior of the building. Photographs 771-9 through 771-12 below show the various holes in the ceilings and roofs in the accessible rooms of the east wing. Shown in these photos are obvious signs of moisture infiltration and severely damaged structural framing.

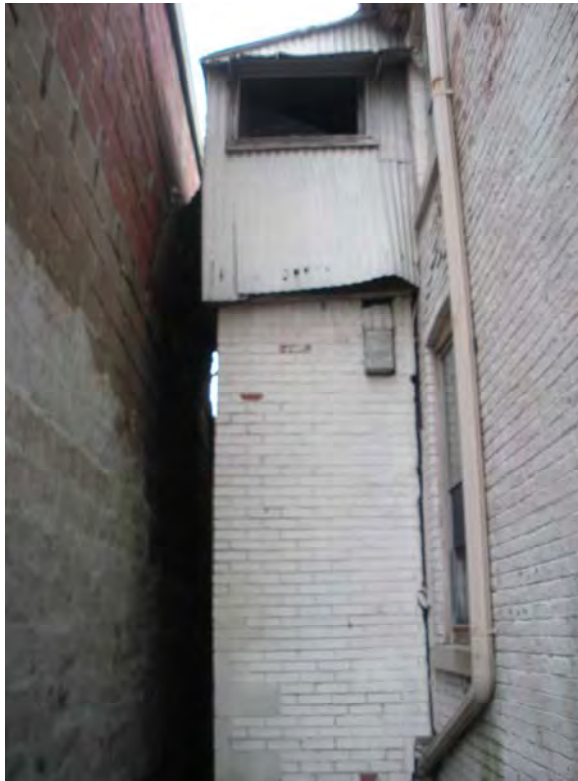
The northern extension of the east wing has shifted away from the main building approximately 1½ inches measured at an elevation 6 feet above the foundation wall as shown in photograph 771-13 and 771-14 below. It should be noted that in 1996 the top of this wall at the roof line only measured 2 inches away from the main building. A measurement of the gap between the two structures at the roof line, however, could not be safely taken; therefore an updated measurement at this location is not known. Overall, it appears the building is shifting northward away from the main structure and towards an adjacent building.

Photograph 771-13: Northern building extension of the east wing.

The overall structural assessment of this entire building is unsatisfactory and the building should be demolished. Specifically, the east wing, the north extension to the east wing, and the back pantry should be demolished due immediate safety concerns. The main structure should be demolished because the roofs are in very poor condition and new bearing walls will be required to keep the structure stable and weather tight.

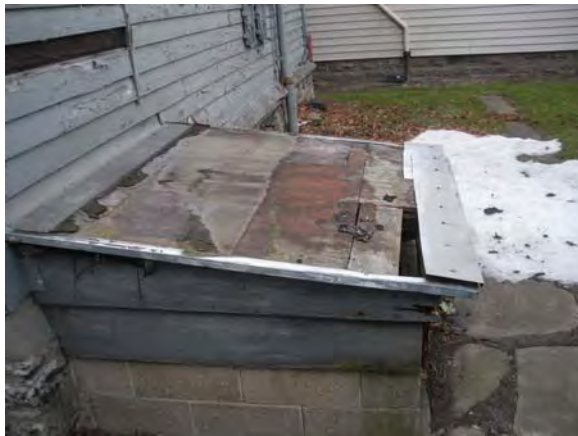
and span from the exterior foundation walls to interior 8 inch tall by 6 inch wide timber support beams. The center timber support beams are then supported by 12x12 inch masonry piers and by the east and west end foundation walls. There are windows in this space located on the north and south foundation walls and a bulkhead entrance at the east end of the building. The windows appear to be in good shape with no visible signs of water leaking into the basement. The bulkhead door is deteriorated, as shown in photograph 777-5, and there are visible signs that water is leaking through this opening into the basement below.

Photograph 777-5: Exterior basement entrance

The rotted exterior siding should be replaced to prevent deterioration of the exterior support walls, sill plate, and to keep the walls structurally stable. To keep the foundation stable, all basement openings should be sealed, especially the basement bulkhead door, to minimize any further water infiltration into the basement and to prevent any foundation wall failure. All broken windows should be boarded up to prevent further moisture infiltration into the interior building space.

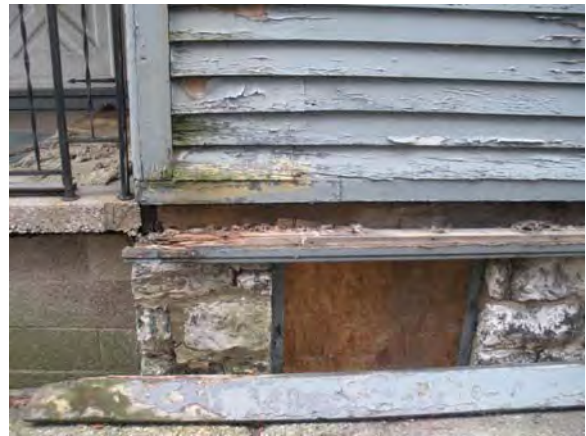
The exterior siding consists of weathered cedar clapboards with visible signs of wear and deterioration. Several areas of the siding are missing and the exterior sheathing is visible. The sill plate protection board has several areas of deteriorating wood, revealing the sill plate and sheathing as shown in photograph 777-6 below.

Photograph 777-6: Deteriorated sill plate protection board

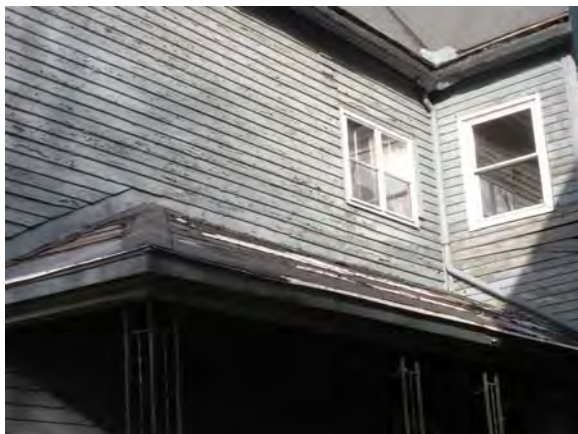
There is a front porch used to access the main entry way to the building. The deck of the porch is covered with plywood and has rotted. It is assumed the decking beneath the plywood topping is also rotted. Photographs 777-7 and 777-8 below show the covered porch and the deteriorating roof deck respectively.

Photograph 777-7: Covered porch

The overall structural assessment of this building is it is in stable condition. The covered entrance roof framing should be replaced or demolished.

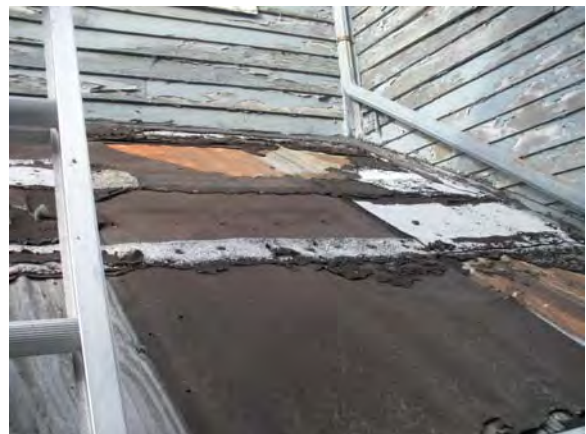
Photograph 777-8: Covered porch roof deck

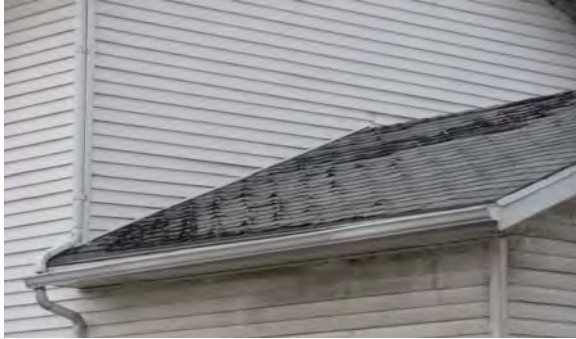
This building has a gable roof oriented east-to-west over the main structure and the 1-story addition. The roofing material on the two roofs are three tab asphalt shingles. The shingles on the main roof of the building are in good condition with no deficiencies. The shingles on the roof over the 1-story eastern portion of the building are in poor condition. There are several areas of cracked and deteriorated shingle tabs as shown in photographs 791-4 and 791-5 below.

Photograph 791-4: South roof section at the eastern end of the building.

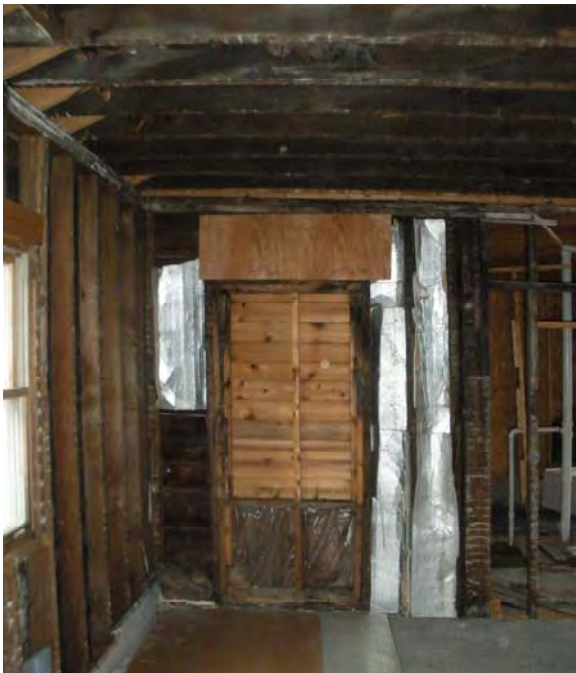
The attic areaway was visible because of missing ceiling drywall as shown in photograph 791-5 below. There is new Oriented Strand Board (OSB) roof sheathing and new 2x6 rafters spaced at 16 inches on center. The center load bearing stud wall in the attic is either missing or was removed, as shown in photograph 791-6 below, causing the ceiling joists to sag from the long clear span. Visible in the attic areaway is a chimney which appears to be new and is in good condition.

Photograph 791-6: Exposed Attic Ceiling joists

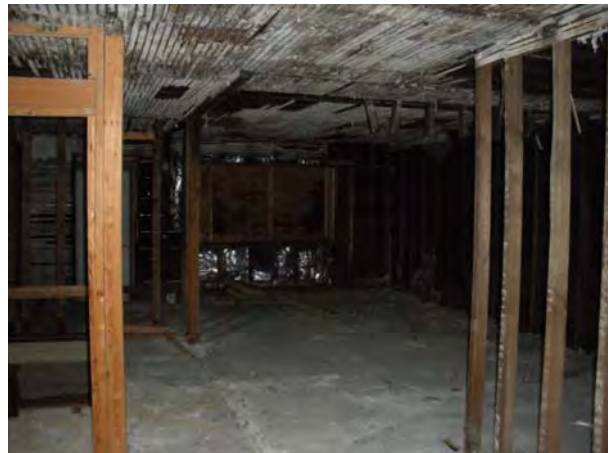
Photograph 791-7: Missing center load bearing wall and sagging ceiling joists

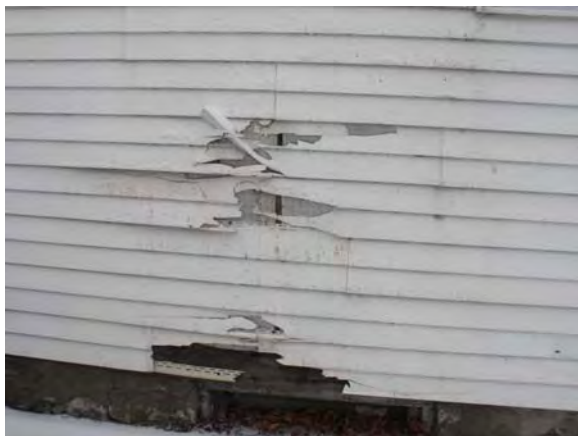
The exterior of the building consists of vinyl siding on all sides of the building with minor damage on the south wall as shown in photographs 791-8 and 791-9 below.

Photograph 791-8: Siding on the south face of the building

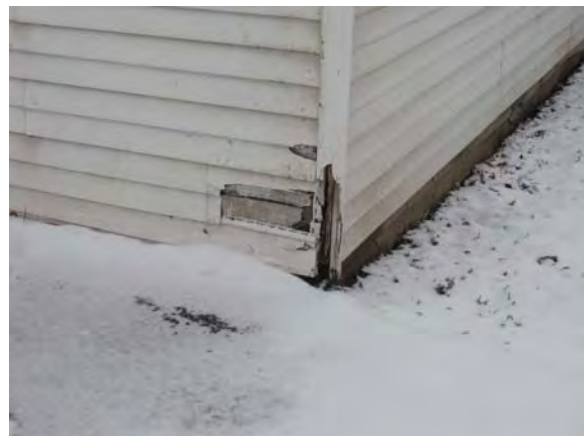
Photograph 791-9: Siding on the south face of the building

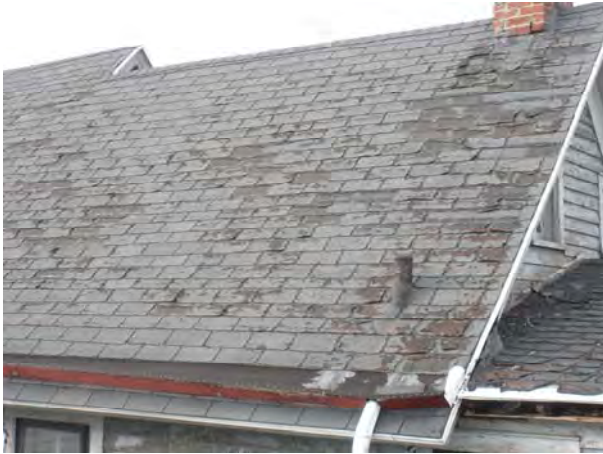
This building has a gable roof oriented east-to-west, a gabled roof section oriented north-to-south and a half hip roof section over the eastern end of the building. The roofing over the entire structure consists of three tab asphalt shingles. The shingles are in poor condition with several noticeable areas of cracked and deteriorated tabs. There are also several areas where shingles are missing on the north and south sides of the main building as shown in photographs 793-4 through 793-8 below. On the eastern end of the property is a detached 3-bay garage with a modified hip roof as shown in photographs 793-9 and 793-10. The roof of the garage is in good condition with no visible signs of shingle deterioration.

Photograph 793-4: South face of main roof at eastern end of the building

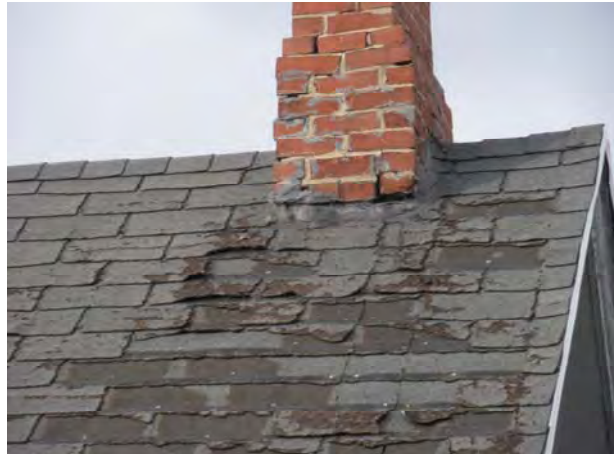
Photograph 793-5: South face main of roof at base of the chimney

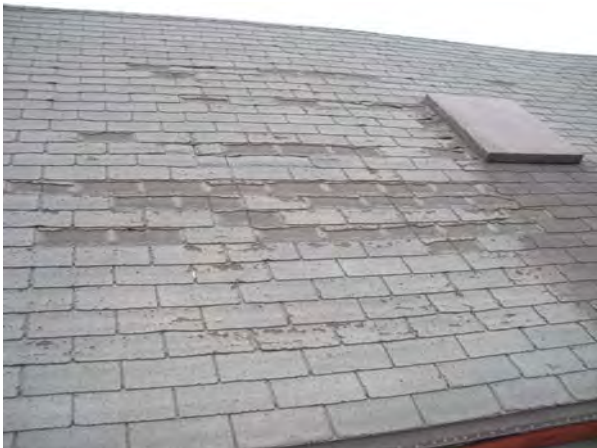
Photograph 793-6: South face of main roof at western end of the building

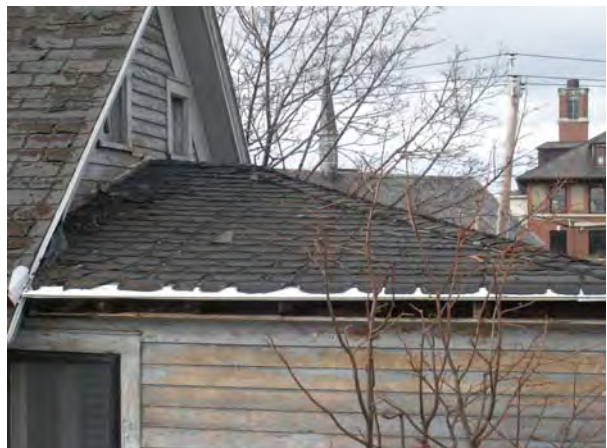
Photograph 793-7: South face of the half hip section at the eastern end of the building

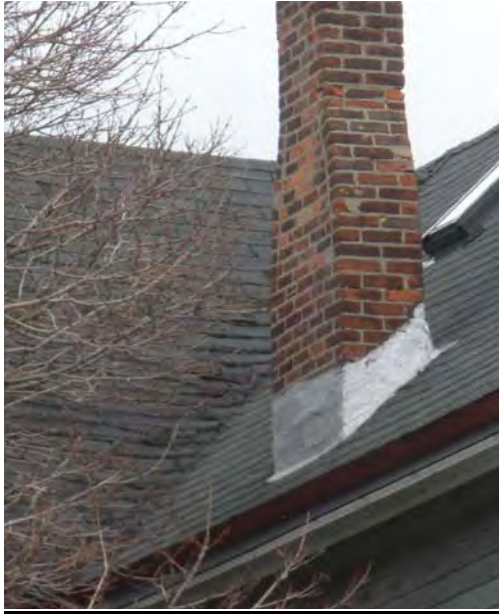
Photograph 793-8: North side of roof at valley

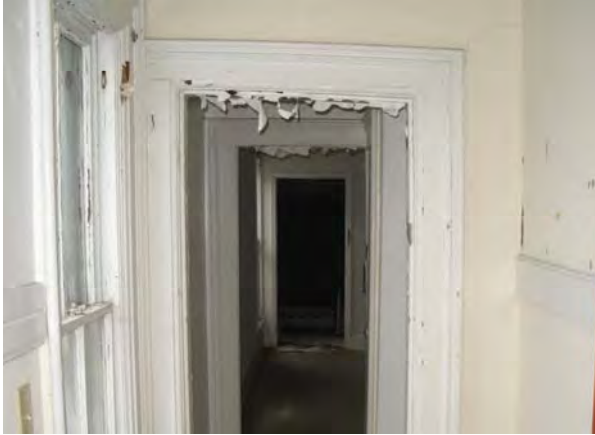
The first floor interior space is constructed of rough sawn 2x4 stud walls covered with a lath and plaster wall and ceiling finish. The plaster has cracked and peeling paint is noticeable on both the walls and the ceilings throughout the entire first floor area as shown in photograph 793-11. Several areas of the ceiling throughout the back portion of the building, including approximately half of the kitchen, have completely fallen down with noticeable water damage to the ceiling. Many of the finished floor boards in this space have buckled and the entire floor is sloped towards the center main bearing wall as shown in photograph 793-12.

Photograph 793-11: Peeling paint

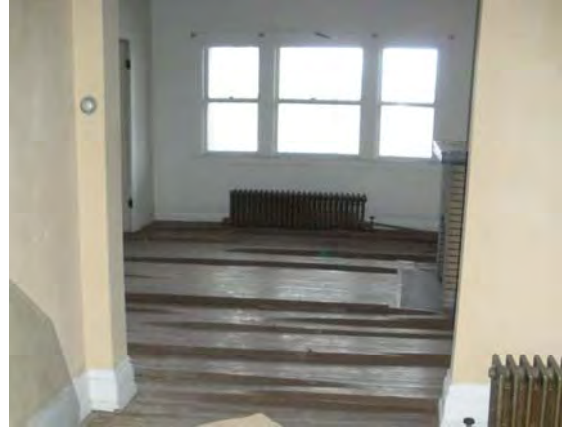
Photograph 793-12: Buckled floor boards

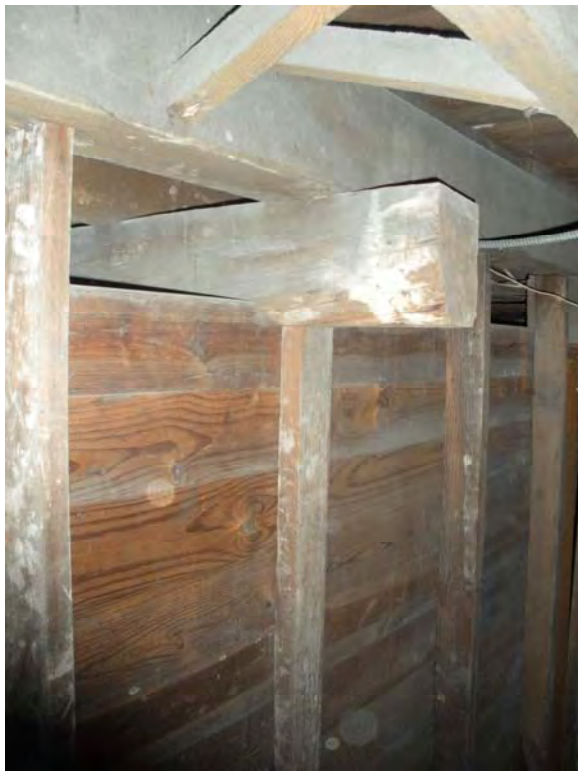
Photograph 793-15: Single 2x4 stud at the center support beam

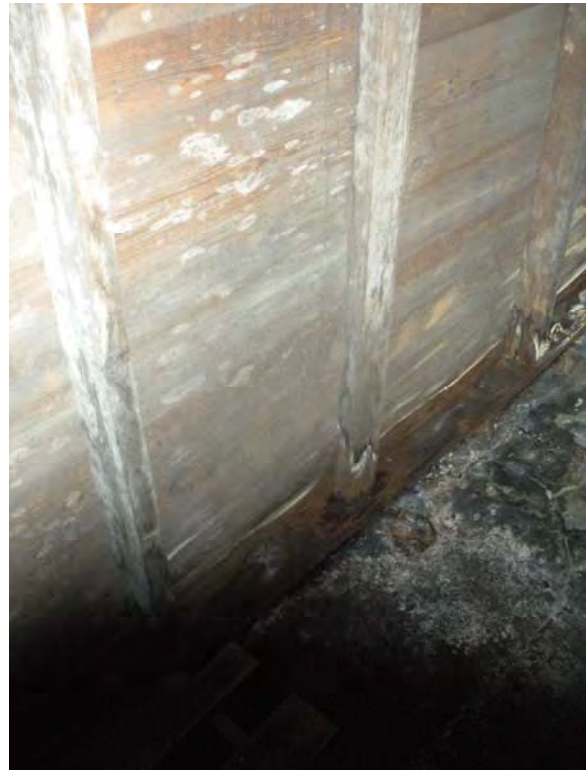
Photographs 793-16: Single 2x4 stud at the base

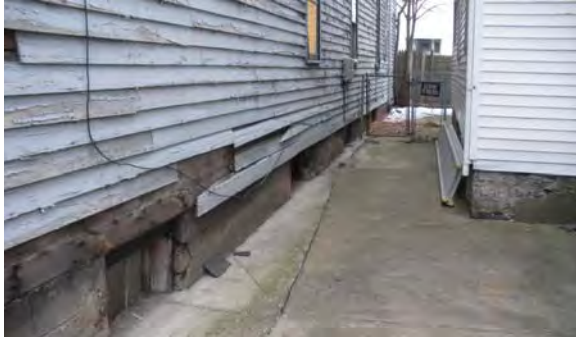
The exterior siding consists of weathered cedar clapboards with visible signs of wear and deterioration. Several areas of the siding are missing and the exterior sheathing visible. Photographs 793-17, 793-18 and photographs 793-1 through 793-3 show the areas of siding that is weathered, deteriorated, or missing.

Photograph 793-17: Missing siding and exposed sheathing on south face of the building

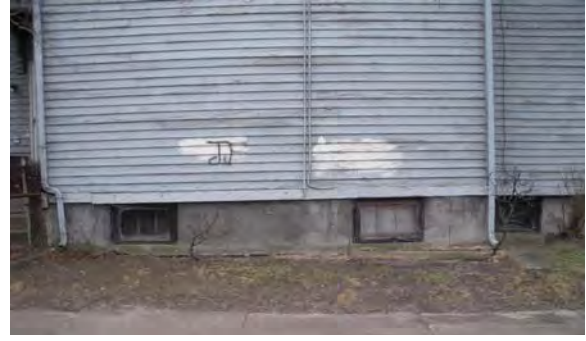
Photograph 793-18: Siding on the north face of the building

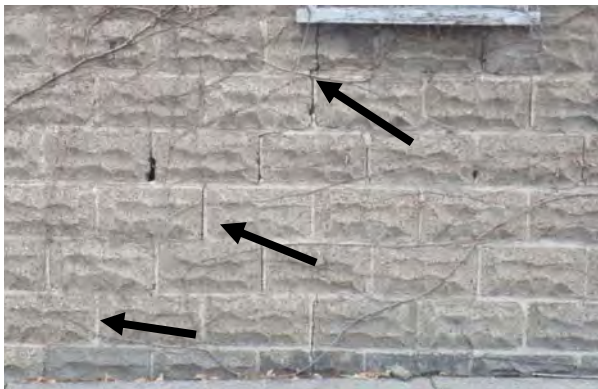
There is a detached 15 foot by 36 foot garage at the rear of the property. The roof is constructed with 2x6 rafters and collar ties spaced at 24 inches on center to support a plywood roof deck. The roof system bears on masonry bearing walls. The garage is in good condition with minor cracking in the masonry due to differential settlement as shown in photographs 793-19 and 793-20 below. Although there are cracks visible in the exterior bearing walls, the garage appears to be stable.

Photograph 793-19: Settlement crack in the masonry wall of the garage

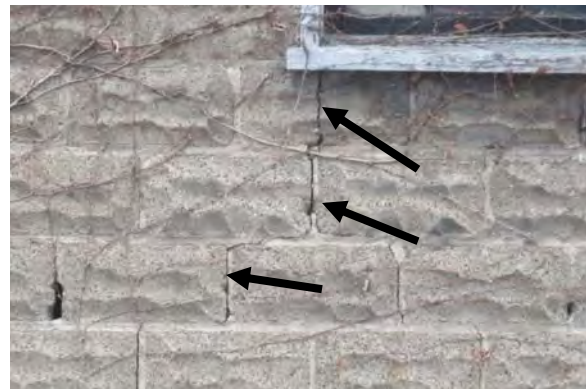
Photograph 793-20: A closer view of the settlement crack in the masonry wall of the garage

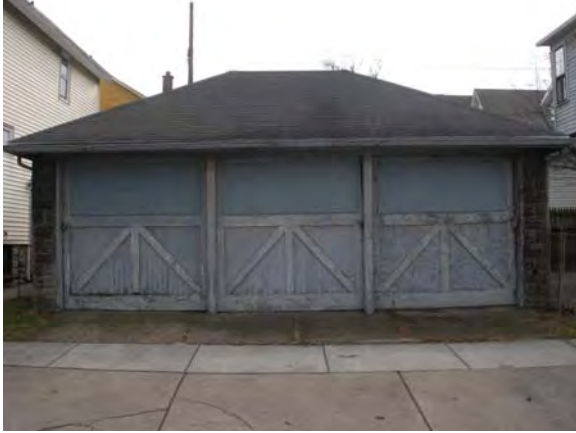
There is a portion of the south wall of the garage that is missing and boarded up with plywood. The adjacent masonry block is not cracked and the wall appears properly shored and in good condition. Photographs 793-19 and 793-20 show the north and south face of the garage respectively.

Photograph 793-19: North side of the garage

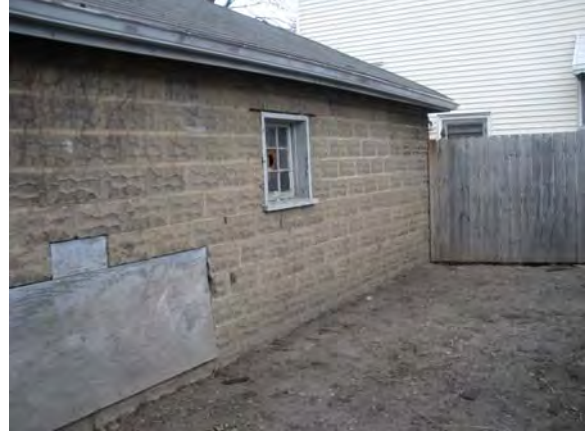
Photograph 793-20: South side of the garage
